JULY–AUGUST 1996

FLIGHT SAFETY

Dubrovnik-bound Flight Crew's Improperly Flown Nonprecision Instrument Approach Results in Controlled-flight-into-terrain Accident

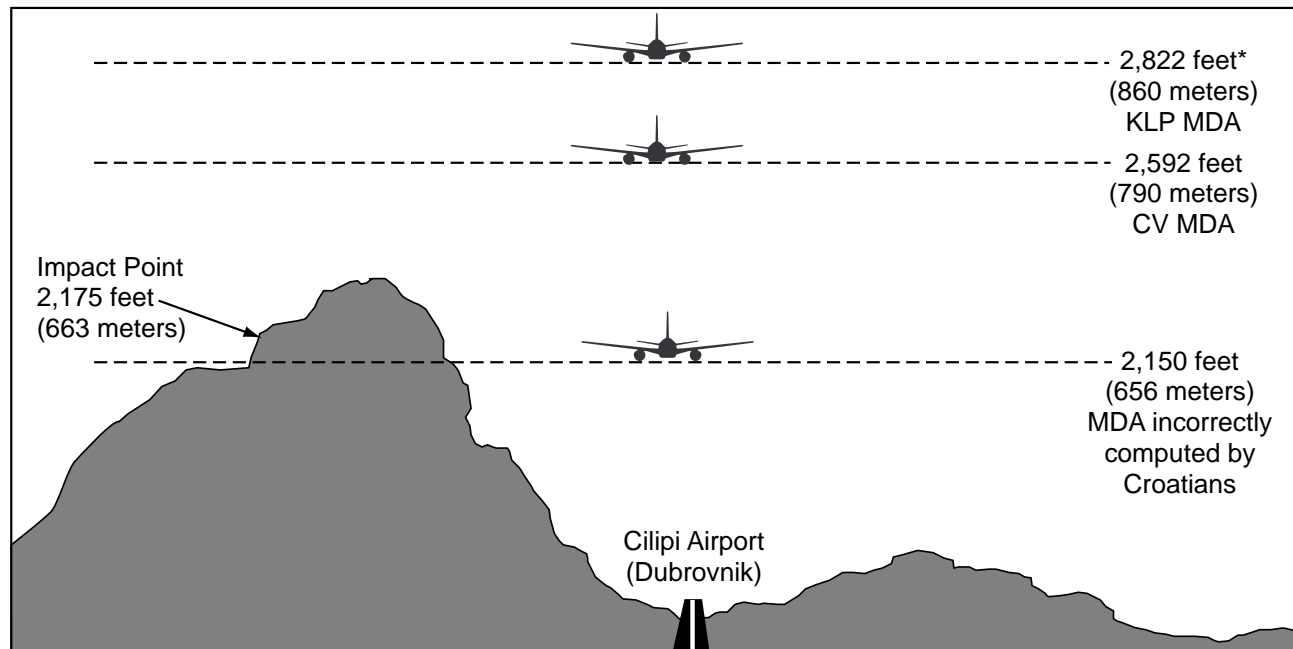
“Correct application of both the U.S. and [ICAO] standards would result in a higher [MDA] than published by the host nation”

Minimum Descent Altitudes (MDAs) Based on ICAO Criteria

* KLP and CV MDAs correctly computed by accident investigators using International Civil Aviation Organization (ICAO) criteria. [Editorial note: KLP and CV are nondirectional radio beacons (NDBs).]
